Justice Watch NZ inc.- summary of:

The death of Steven Cranston

This document presents an independent examination of the death of Steven Cranston on State Highway 23 on 4 September 2024. It is a summary of the investigation undertaken by Fraser Cranston and Andrew Major, based on witness evidence, scene assessment, and analytical reconstruction. The report sets out a detailed chronology of events in order to identify the sequence of events and the circumstances in which the death occurred. It further outlines the relevant legal duties and prosecution framework applicable to those events. It does not make findings of criminal liability but presents the available material in a structured form to enable proper assessment of the facts in accordance with the law.

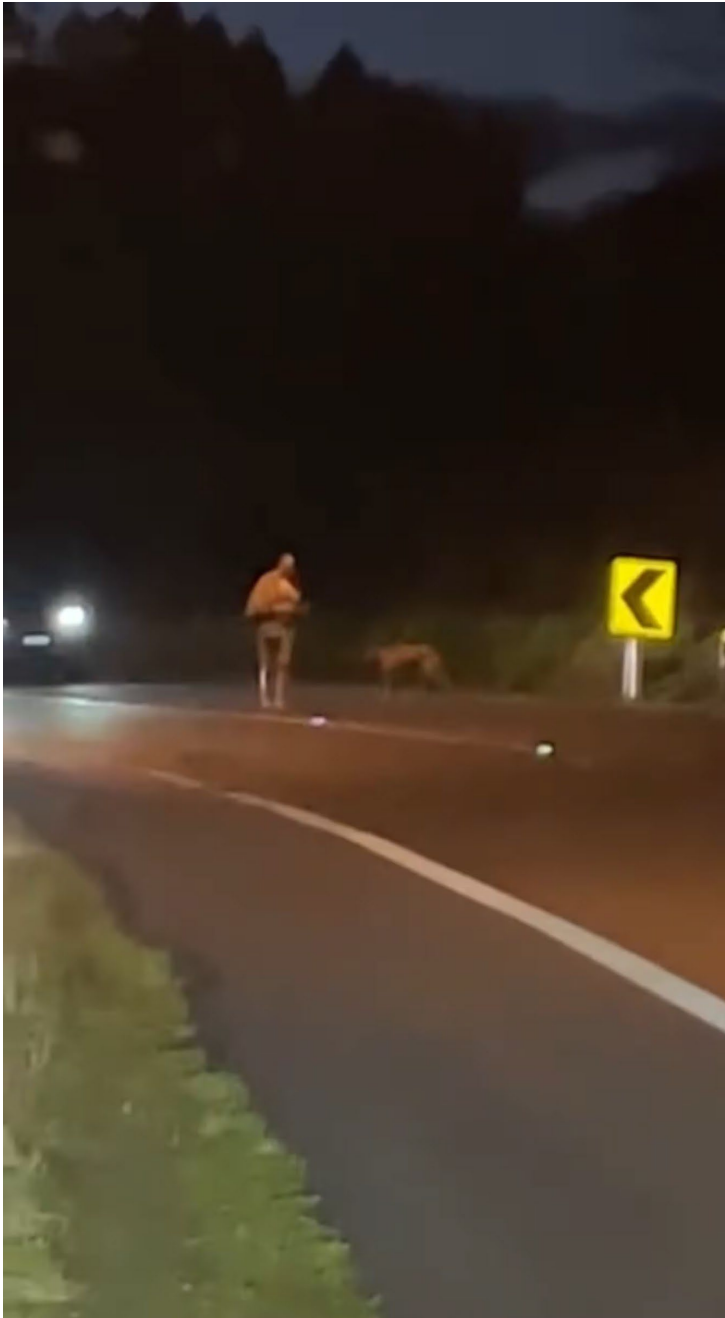
At approximately 6:30pm, Steven and his dog were observed further along State Highway 23.

- Vehicles were travelling with headlights on.
- Steven had reached the intersection with Okete Road.
- He was photographed at this location.
- Witnesses reported that Steven “looked lost” and appeared agitated.

Steven died on State Highway 23 approximately 500 metres beyond the Okete Road intersection.

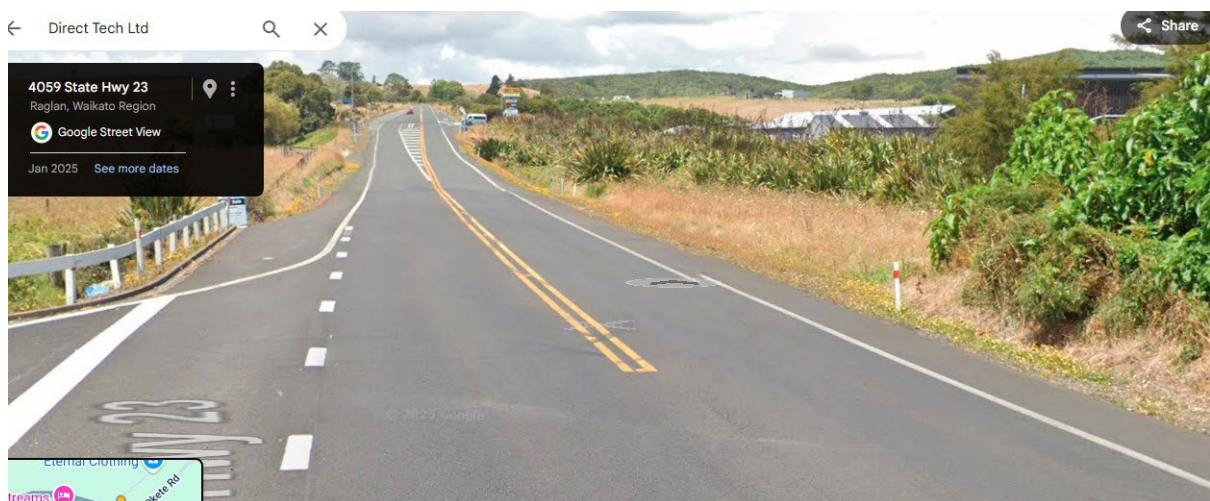
The relevant section of State Highway 23:

- Extends approximately 500 metres from the Okete Road intersection to the point of impact
- Proceeds relatively straight and uphill
- The first approximately 250 metres is marked with double yellow lines, indicating a no-passing zone

A witness described the convoy of four vehicles as travelling at approximately 80–90 km/h, with spacing between vehicles of approximately 40–50 metres.

- Remaining distance from the lead vehicle to the end of the 500m section: approximately 347 metres
- Time available at 85 km/h: approximately 14.7 seconds

- Required relative speed gain: approximately 12.8 m/s
- Required total speed: approximately 36.4 m/s (≈ 131 km/h)
